## Rock Slopes Stability Analysis along the Qaywan-Mokba Road in Sulaymaniyah Governorate, Northeastern Iraq

### Abstract

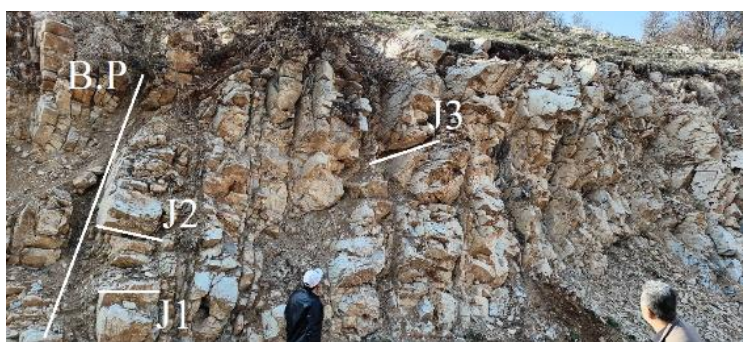
**Fig.8.** Bedding plane and discontinuity set for station 2

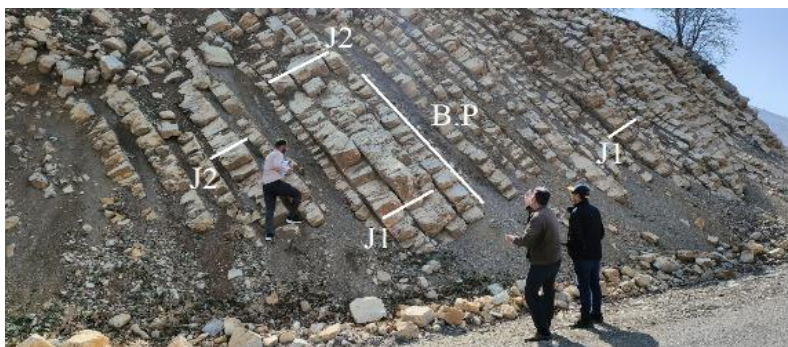
**Fig.10.** Bedding plane and discontinuity set for station 3

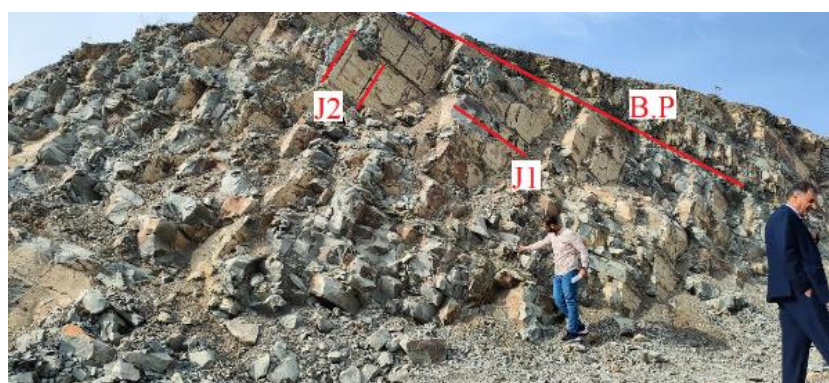
**Fig.18.** Bedding plane and discontinuity set for station 7.
